Contract #: 04-0120F4Cty: SF/ALA Rte: 80 PM: 13.2/13.9File #: 82.28**WELDING INSPECTION REPORT****Resident Engineer:** Siegenthaler, Peter**Address:** 333 Burma Road**City:** Oakland, CA 94607**Report No:** WIR-017294**Date Inspected:** 04-Oct-2010**Project Name:** SAS Superstructure**OSM Arrival Time:** 700**Prime Contractor:** American Bridge/Fluor Enterprises, a JV**OSM Departure Time:** 1530**Contractor:** Westmont Industries**Location:** Santa Fe Springs, CA.**CWI Name:** R. Rodriguez, R. Dominguez**CWI Present:** Yes No**Inspected CWI report:** Yes No N/A**Rod Oven in Use:** Yes No N/A**Electrode to specification:** Yes No N/A**Weld Procedures Followed:** Yes No N/A**Qualified Welders:** Yes No N/A**Verified Joint Fit-up:** Yes No N/A**Approved Drawings:** Yes No N/A**Approved WPS:** Yes No N/A**Delayed / Cancelled:** Yes No N/A**Bridge No:** 34-0006**Component:** Travelers**Summary of Items Observed:**

WELDING INSPECTION REPORT

E2/E3-EB Traveler

Elevated Truss Section

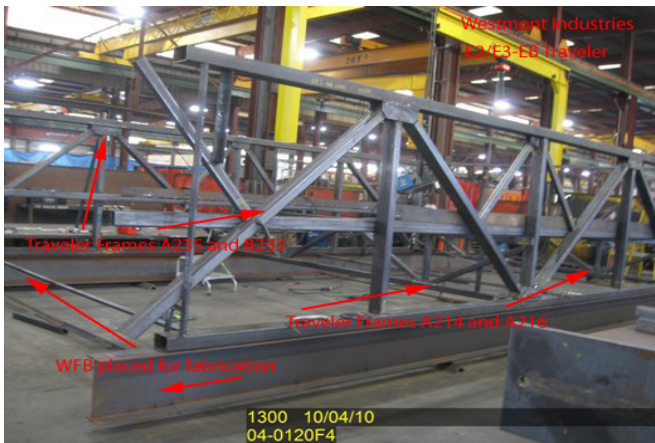
On this date, the QA Inspector observed Westmont Industries (WMI), production welder Raymundo Anaya and production fitter, Cesar Canales continuing to perform activities for the fabrication of the Travelers. The QA Inspector observed Mr. Anaya and Mr. Canales utilize the overhead bay crane, chain and hook to lift up the completed frame assemblies identified as A235, B235, A214 and A216. Once these frame assemblies were lifted, the QA Inspector observed that the assemblies were placed nearby the area which the assemblies will be fit and welded. The QA Inspector then observed Mr. Anaya and Mr. Canales utilize the overhead bay crane, chain and hook to lift up the completed frame assembly, identified as A235 and place the frame on one of the temporary Wide Flange Beams (WFB's) which had been previously placed, for the purpose of fabricating the Travelers. After the Frame assembly was secured, the QA Inspector then observed Frame Assembly B235 being lifted and placed on the second WFB, which had been previously placed for the fabrication of the Travelers. After this frame assembly was secure, the QA Inspector then observed Frame assembly identified as A214 and A216, being lifted and placed, in the same manner, between frame assembly A235 and B235, in a perpendicular fashion. The QA Inspector then observed Mr. Anaya and Mr. Canales reference the shop drawings and verify dimensions, utilizing a tape measure and framing squares to insure correct placement, of these four Traveler Frame assemblies. After observing Mr. Anaya and Mr. Canales verifying dimensions, the QA Inspector then observed numerous C-Clamps placed and temporary angle iron being tack welded between the frames. The QA Inspector spoke with Mr. Anaya and he explained that the C-Clamps and angle were placed to secure the four frames together. Near the end of the shift, the QA Inspector observed that FCAW tack welding had started on these fit-up and placed frame assemblies. See attached picture below.
